# **CCTV Survey Report Prepared For:**

**St Judes Housing Association  
St Judes House  
Plymouth  
Devon**

**Test 260401 - CCTV Survey Report : 26/04/18**

**Site: 26 Ferndale Gardens, Plymouth**

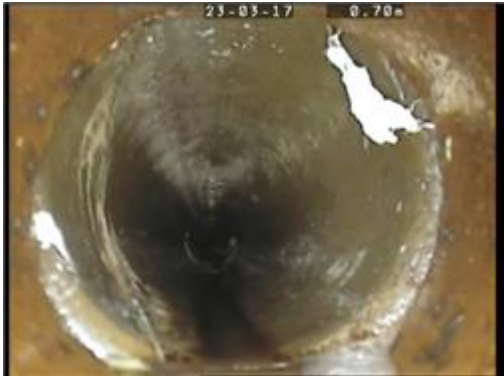
Pos	Code	Description	Image
00.00m	MH	Start node type, manhole MH F1	
00.00m	WL	Water level: 0% Height/Diameter	
00.70m	R	Roots - Grade 2	Image Provided - Ref: 0_2

<p><b>Section: 1</b></p> <p>From: MH F1 To: MH F2</p>	<p>The line has a number of defects that appear to be affecting the serviceability of the drain. Blockages are likely to recur. Either excavation and replacement or structurally lining the drain are remedial options.</p>	<p><b>DRB Grade: C</b> <b>Pipe Size: 100</b> <b>Material: Vitrified Clay (i.e. all clayware)</b> <b>Use: Foul</b></p>
<p><b>Section: 2</b></p> <p>From: MH F2 To: MH F3</p>	<p>The fracture has potential to increase in severity. Patch lining the defect is likely to prevent further deterioration. There is also evidence of vermin.</p>	<p><b>DRB Grade: B</b> <b>Pipe Size: 100</b> <b>Material: Vitrified Clay (i.e. all clayware)</b> <b>Use: Foul</b></p>
<p><b>Section: 3</b></p> <p>From: MH F3 To: MH F4</p>	<p>The displaced joint is affecting flow and probably allowing infiltration. The best repair recommendation would be to excavate and replace. Dependant on location there is potential for patch lining with a view to 'smoothing out' the defect and bring the pipe back to water tightness.</p>	<p><b>DRB Grade: C</b> <b>Pipe Size: 100</b> <b>Material: Vitrified Clay (i.e. all clayware)</b> <b>Use: Foul</b></p>

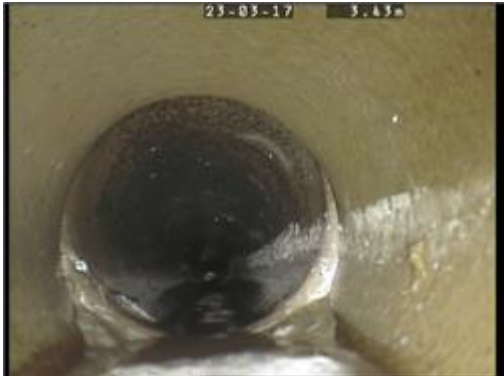
03.43m	JDM	Joint displaced medium - Grade 2	Image Provided - Ref: 0_3

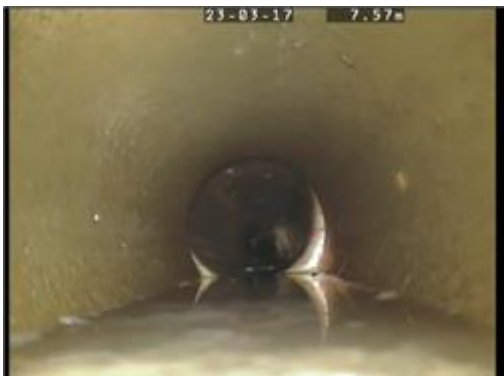
05.06m	DES	Settled deposits fine: 20% Cross sectional area loss - Grade 2	
07.57m	WL	Water level: 15% Height/Diameter	Image Provided - Ref: 0_5

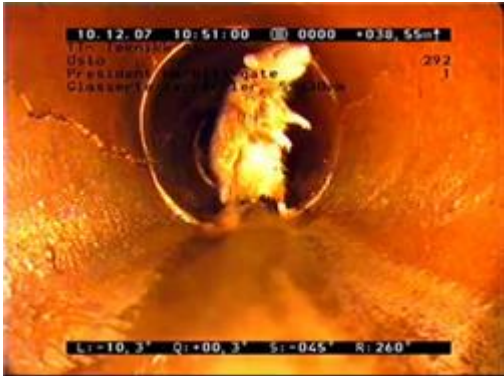
Pos	Code	Description	Image
00.00m	MH	Start node type, manhole MHF2	
00.00m	WL	Water level: 0% Height/Diameter	
38.60m	V	Vermin - Grade 1	Image Provided - Ref: 1_2

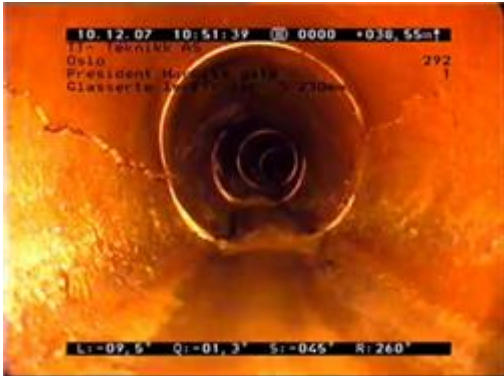
38.90m	FLJ	Fracture longitudinal at 09 o'clock at joint - Grade 3	Image Provided - Ref: 1_3

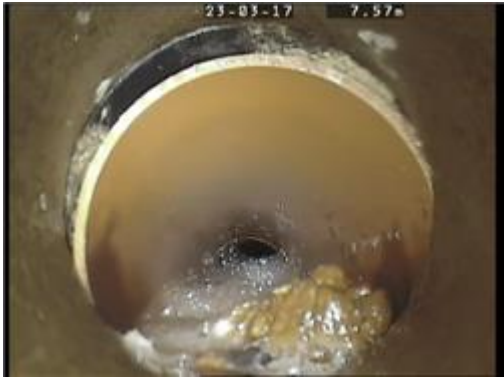
Pos	Code	Description	Image
00.00m	MH	Start node type, manhole F5	
00.00m	WL	Water level: 0% Height/Diameter	
03.20m	JN	Junction at 09 o'clock: 100mm Diameter	
07.57m	JDL	Joint displaced large - Grade 3	Image Provided - Ref: 3_2

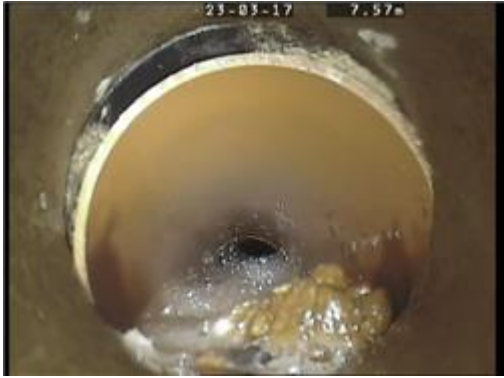
07.57m	MCPVC	Material of pipe changes to Polyvinyl Chloride	Image Provided - Ref: 3_3

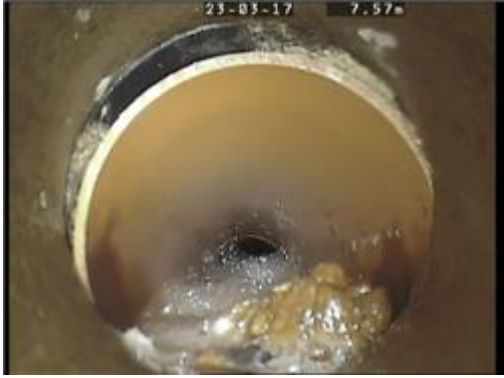
07.57m	OB	Other obstacles: 20% Cross sectional area loss - Grade 3 Soft blockage	Image Provided - Ref: 3_4
