# **CCTV Survey Report Prepared For:**

**St Judes Housing Association  
St Judes House  
Plymouth  
Devon**

**Test 260401 - CCTV Survey Report : 26/04/18**

**Site: 26 Ferndale Gardens, Plymouth**

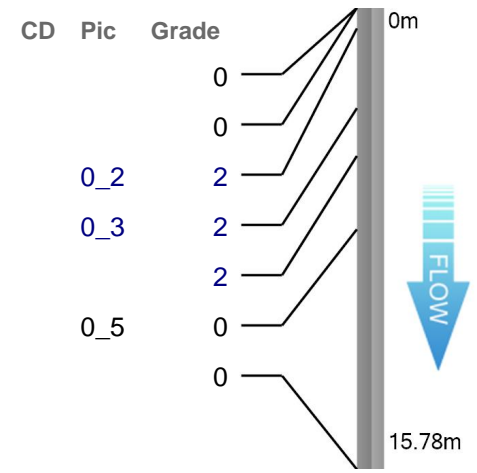
**Section 1**

Position	Code	Description	CD	Pic	Grade
00.00m	MH	Start node type, manhole			0
00.00m	WL	Water level 0%			0
00.70m	R	Roots	0_2		2
03.43m	JDM	Joint displaced medium	0_3		2
05.06m	DES	Settled deposits fine 20%			2
07.57m	WL	Water level 15%	0_5		0
15.78m	MHF	Finish node type, manhole			0

<p><b>Section: 1</b></p> <p>From: MH F1 To: MH F2</p>	<p>The line has a number of defects that appear to be affecting the serviceability of the drain. Blockages are likely to recur. Either excavation and replacement or structurally lining the drain are remedial options.</p>	<p><b>DRB Grade: C</b> <b>Pipe Size: 100</b> <b>Material: Vitrified Clay (i.e. all clayware)</b> <b>Use: Foul</b></p>
<p><b>Section: 2</b></p> <p>From: MH F2 To: MH F3</p>	<p>The fracture has potential to increase in severity. Patch lining the defect is likely to prevent further deterioration. There is also evidence of vermin.</p>	<p><b>DRB Grade: B</b> <b>Pipe Size: 100</b> <b>Material: Vitrified Clay (i.e. all clayware)</b> <b>Use: Foul</b></p>
<p><b>Section: 3</b></p> <p>From: MH F3 To: MH F4</p>	<p>The displaced joint is affecting flow and probably allowing infiltration. The best repair recommendation would be to excavate and replace. Dependant on location there is potential for patch lining with a view to 'smoothing out' the defect and bring the pipe back to water tightness.</p>	<p><b>DRB Grade: C</b> <b>Pipe Size: 100</b> <b>Material: Vitrified Clay (i.e. all clayware)</b> <b>Use: Foul</b></p>

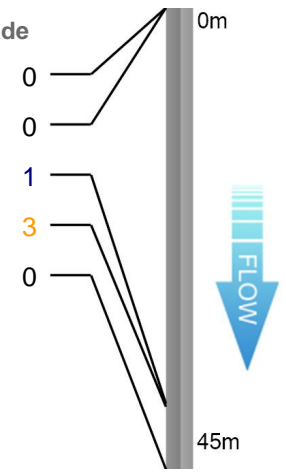
**Section 2**

Position	Code	Description	CD	Pic	Grade
00.00m	MH	Start node type, manhole			0
00.00m	WL	Water level 0%			0
38.60m	V	Vermin		1_2	1
38.90m	FLJ	Fracture longitudinal 09 at joint		1_3	3
45.00m	MHF	Finish node type, manhole			0

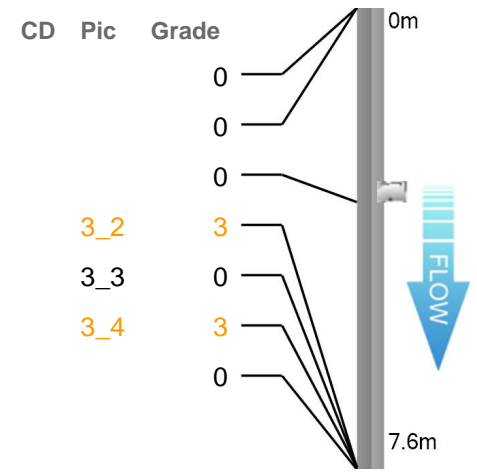
Position	Code	Description	CD	Pic	Grade
00.00m	MH	Start node type, manhole			0
00.00m	WL	Water level 0%			0
03.20m	JN	Junction 09 : 100mm Diameter			0
07.57m	JDL	Joint displaced large		3_2	3
07.57m	MC	Material of drain/sewer changes		3_3	0
07.57m	OB	Other obstacles 20%		3_4	3
07.60m	SA	Survey abandoned			0

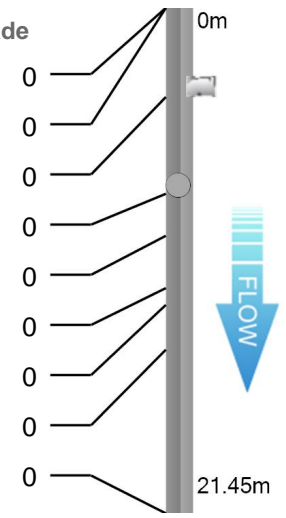
Position	Code	Description	CD	Pic	Grade
00.00m	MH	Start node type, manhole			0
00.00m	WL	Water level 0%			0
03.78m	JN	Junction 09 : 100mm Diameter			0
07.89m	CN	Connection other than junction 12 : 100mm Diameter			0
09.67m	LRF	Line of drain/sewer deviates right [full]			0
11.89m	SC	Dimension of drain/sewer changes : 150mm Diameter			0
12.60m	MC	Material of drain/sewer changes			0
14.50m	WL	Water level 20%			0
21.45m	MHF	Finish node type, manhole			0
